Analysis, Assessment, and Remediation of Highway Rockfall

Abstract: Preventing geological disasters such as highway rock collapses is crucial for ensuring traffic safety and social stability. Traditional research often relies on on-site investigations to identify collapses, which can delay the remediation process. In this study, we focused on a highway rock collapse case in Shuangfeng Town, Longchang City. Using a combination of remote sensing imagery analysis, on-site verification, and surveying, we comprehensively obtained the geological characteristics and surrounding environmental information of the dangerous rock mass. Through detailed analysis of the lithology, structure, weathering degree, and other features of the dangerous rock mass, and considering geological structures, climatic conditions, human activities, and other internal and external factors, we explored the formation mechanism of the rock collapse in depth. Subsequently, we assessed the potential threat level of the dangerous rock mass to provide a scientific basis for the design of the remediation plan. The results indicate that the dangerous rock mass in this area is primarily composed of gray thick-bedded to b

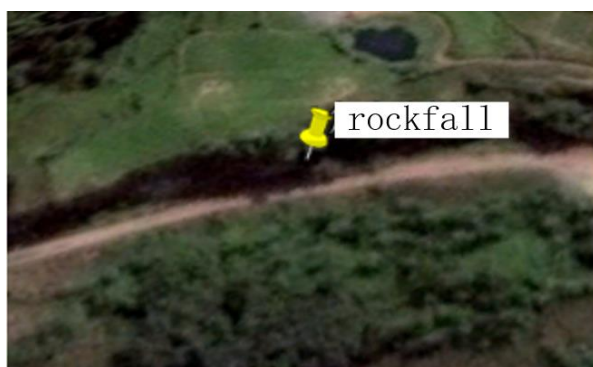
(a) Remote Sensing Image

Combining the above info and Figure 1, the collapse site is on a hillside. The collapse mass has a rough, uneven surface. Scree of various sizes is piled at the slope's foot, with little or no vegetation. The terrain is higher in the east and lower in the west. The slope is steep at the top and gentle at the bottom, and the overall slope is relatively straight and uniform, with well - developed vegetation. From the site photo, the deposit at the lower slope is conical, lacking obvious vegetation, indicating high freshness of the collapse deposits. This shape is usually a direct result of a collapse event. The steep rock walls and fractures on the upper slope further confirm this. These fractures and exposed rock faces are

consistent with collapse characteristics, so this area can be identified as a collapse zone.

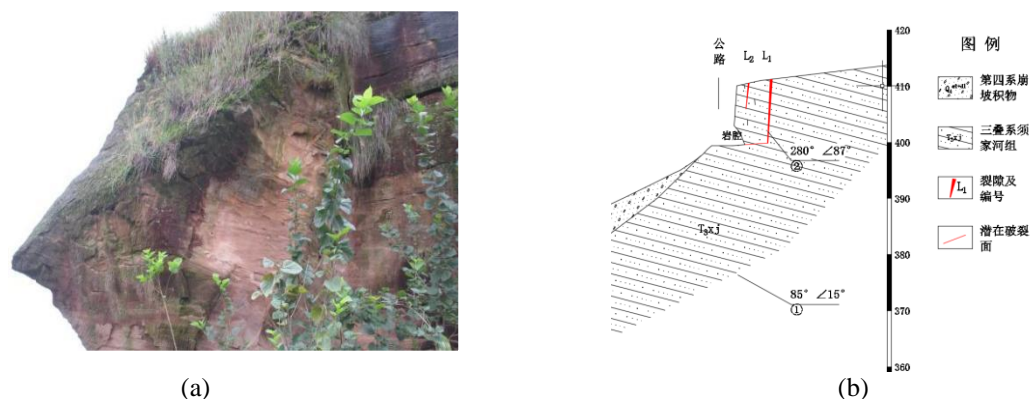
Figure 2 (a)Morphological characteristics of hazardous rock mass;(b)Geological Profile of Dangerous Rocks

The dangerous rock mass is located on the eastern slope of the survey area. The slope is a reverse slope, steep at the top and gentle at the bottom, with a steep cliff formed at the slope shoulder. It mainly consists of grey thick - bedded to blocky fine - grained sandstone from the Middle Jurassic Shaximiao Formation, with a dip of $85^\circ \angle 15^\circ$, and the rock is hard. The middle and lower parts of the slope are covered by Quaternary Holocene slope deposits and residual deposits, mainly consisting of silt and clayey silt with a small amount of boulders. The vegetation on the slope is relatively lush, mainly consisting of trees and shrubs, while the slope top is gentler, mainly with herbaceous plants (Figure 2(a)).

The dangerous rock mass is approximately triangular in plan view and rectangular in elevation. It has a base height of 397.1 m, a top height of 408.4 m, a height difference of 11.3 m, a width of 7.4 m, a length of 13.4 m, and a volume of 588 m³, classifying it as a super - large dangerous rock mass. Two sets of steeply dipping "X" joints control the development and deformation of the dangerous rock mass. Joint ① has a dip of $15^\circ \angle 88^\circ$, a joint density of about 3.2 m per joint, is closed, short - extending, with a smooth joint surface and poor combination, classified as a hard structural surface. Joint ② has a dip of $280^\circ \angle 87^\circ$, a joint density of 1.8 m per joint, is slightly open, long - extending, with a smooth joint surface, slightly rough, partially filled with weathered soil, and poor combination, also classified as a hard structural surface. Parallel to Joint ②, there are two tension fractures, L1 and L2, which both penetrate the dangerous rock mass in plan view. In profile, L1 penetrates the entire dangerous rock mass. L1 is 2 - 8 cm wide, while L2 is less than 3 cm wide and disappears (Figure 2(b)).

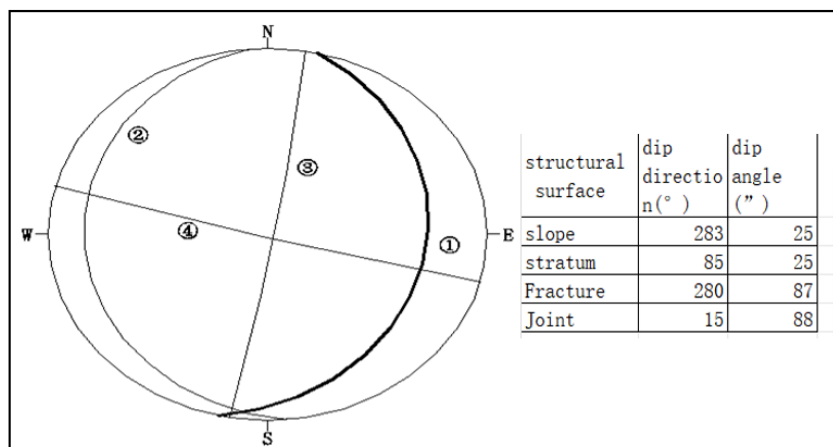
Fig 3. Stereoscopic projection of structural plane and slope surface

Rockfalls occur along weak structural planes within the rock mass. There are three main sets of structural planes (Fig. 3) with dips of ① $85^\circ \angle 15^\circ$, ② $280^\circ \angle 87^\circ$, and ③ $15^\circ \angle 160^\circ$, with widths of 0 - 80 mm. Some fractures are filled with weathered soil. L1 is almost through, and L2 is connected at the top. Under the rock's self - weight, compression or plastic flow widens the steep fractures, causing stable rock to become potentially unstable and leading to collapse.

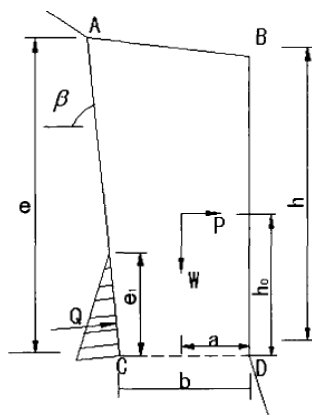
Figure 4. Calculation model for stability coefficient of toppling collapse

The failure deformation mode of this dangerous rock mass is overturning - type, and the model is shown in the

According to the "Specification for Geological Disaster Prevention Engineering Investigation" (DB50/143-2003), this prevention and control project is classified as Grade III. Calculations using the formula show a stability coefficient of 1.442 for Condition I and 1.237 for Condition II. This indicates the dangerous rock mass is relatively stable in natural conditions but unstable in heavy rain, with storms being the main threat to its stability (Table 3).
